EFFECT OF BALL GEOMETRY ON ENDURANCE LIMIT IN BENDING OF DRILLED BALLS

HAROLD E. MUNSON

TRW MARLIN ROCKWELL DIVISION

CONTRACT NAS3-17351

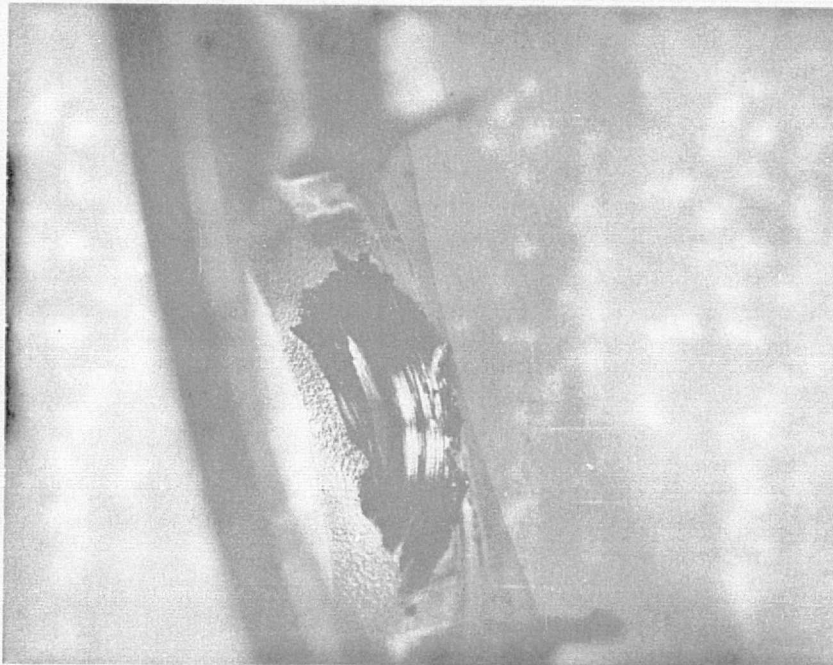
FIGURE 20 - Typical Damaged Ball Pocket Rib, from Contact with Tilted Design B Ball.

Bearings incorporating Design B balls were run at 20,000 rpm (3,000,000 DN) but were unable to operate at scheduled load, 30480 newtons (6,850 lbs.). Several tests were made. In each test, one or more balls tilted excessively, wearing into the restraining ribs in the ball pocket, and abrading one or both sides of the ball. (See Figures 19 and 20.) With the braking action which occurred at this time, there was light skidding on the races. In each case, audible indications of bearing distress were observed as load was being increased through the 15,575 newtons (3,500 lbs.) range.
